ROCK CAVE, W. VA.
SEA/CRAWFORD 15' QUADRANGLE
N3845—WB015/7.5

LANDSLIDES AND RELATED FEATURES OF THE ROCK CAVE, W. VA. QUADRANGLE

GREGORY C. OHLMACHER

OPEN FILE MAP 83-80 (G-14)

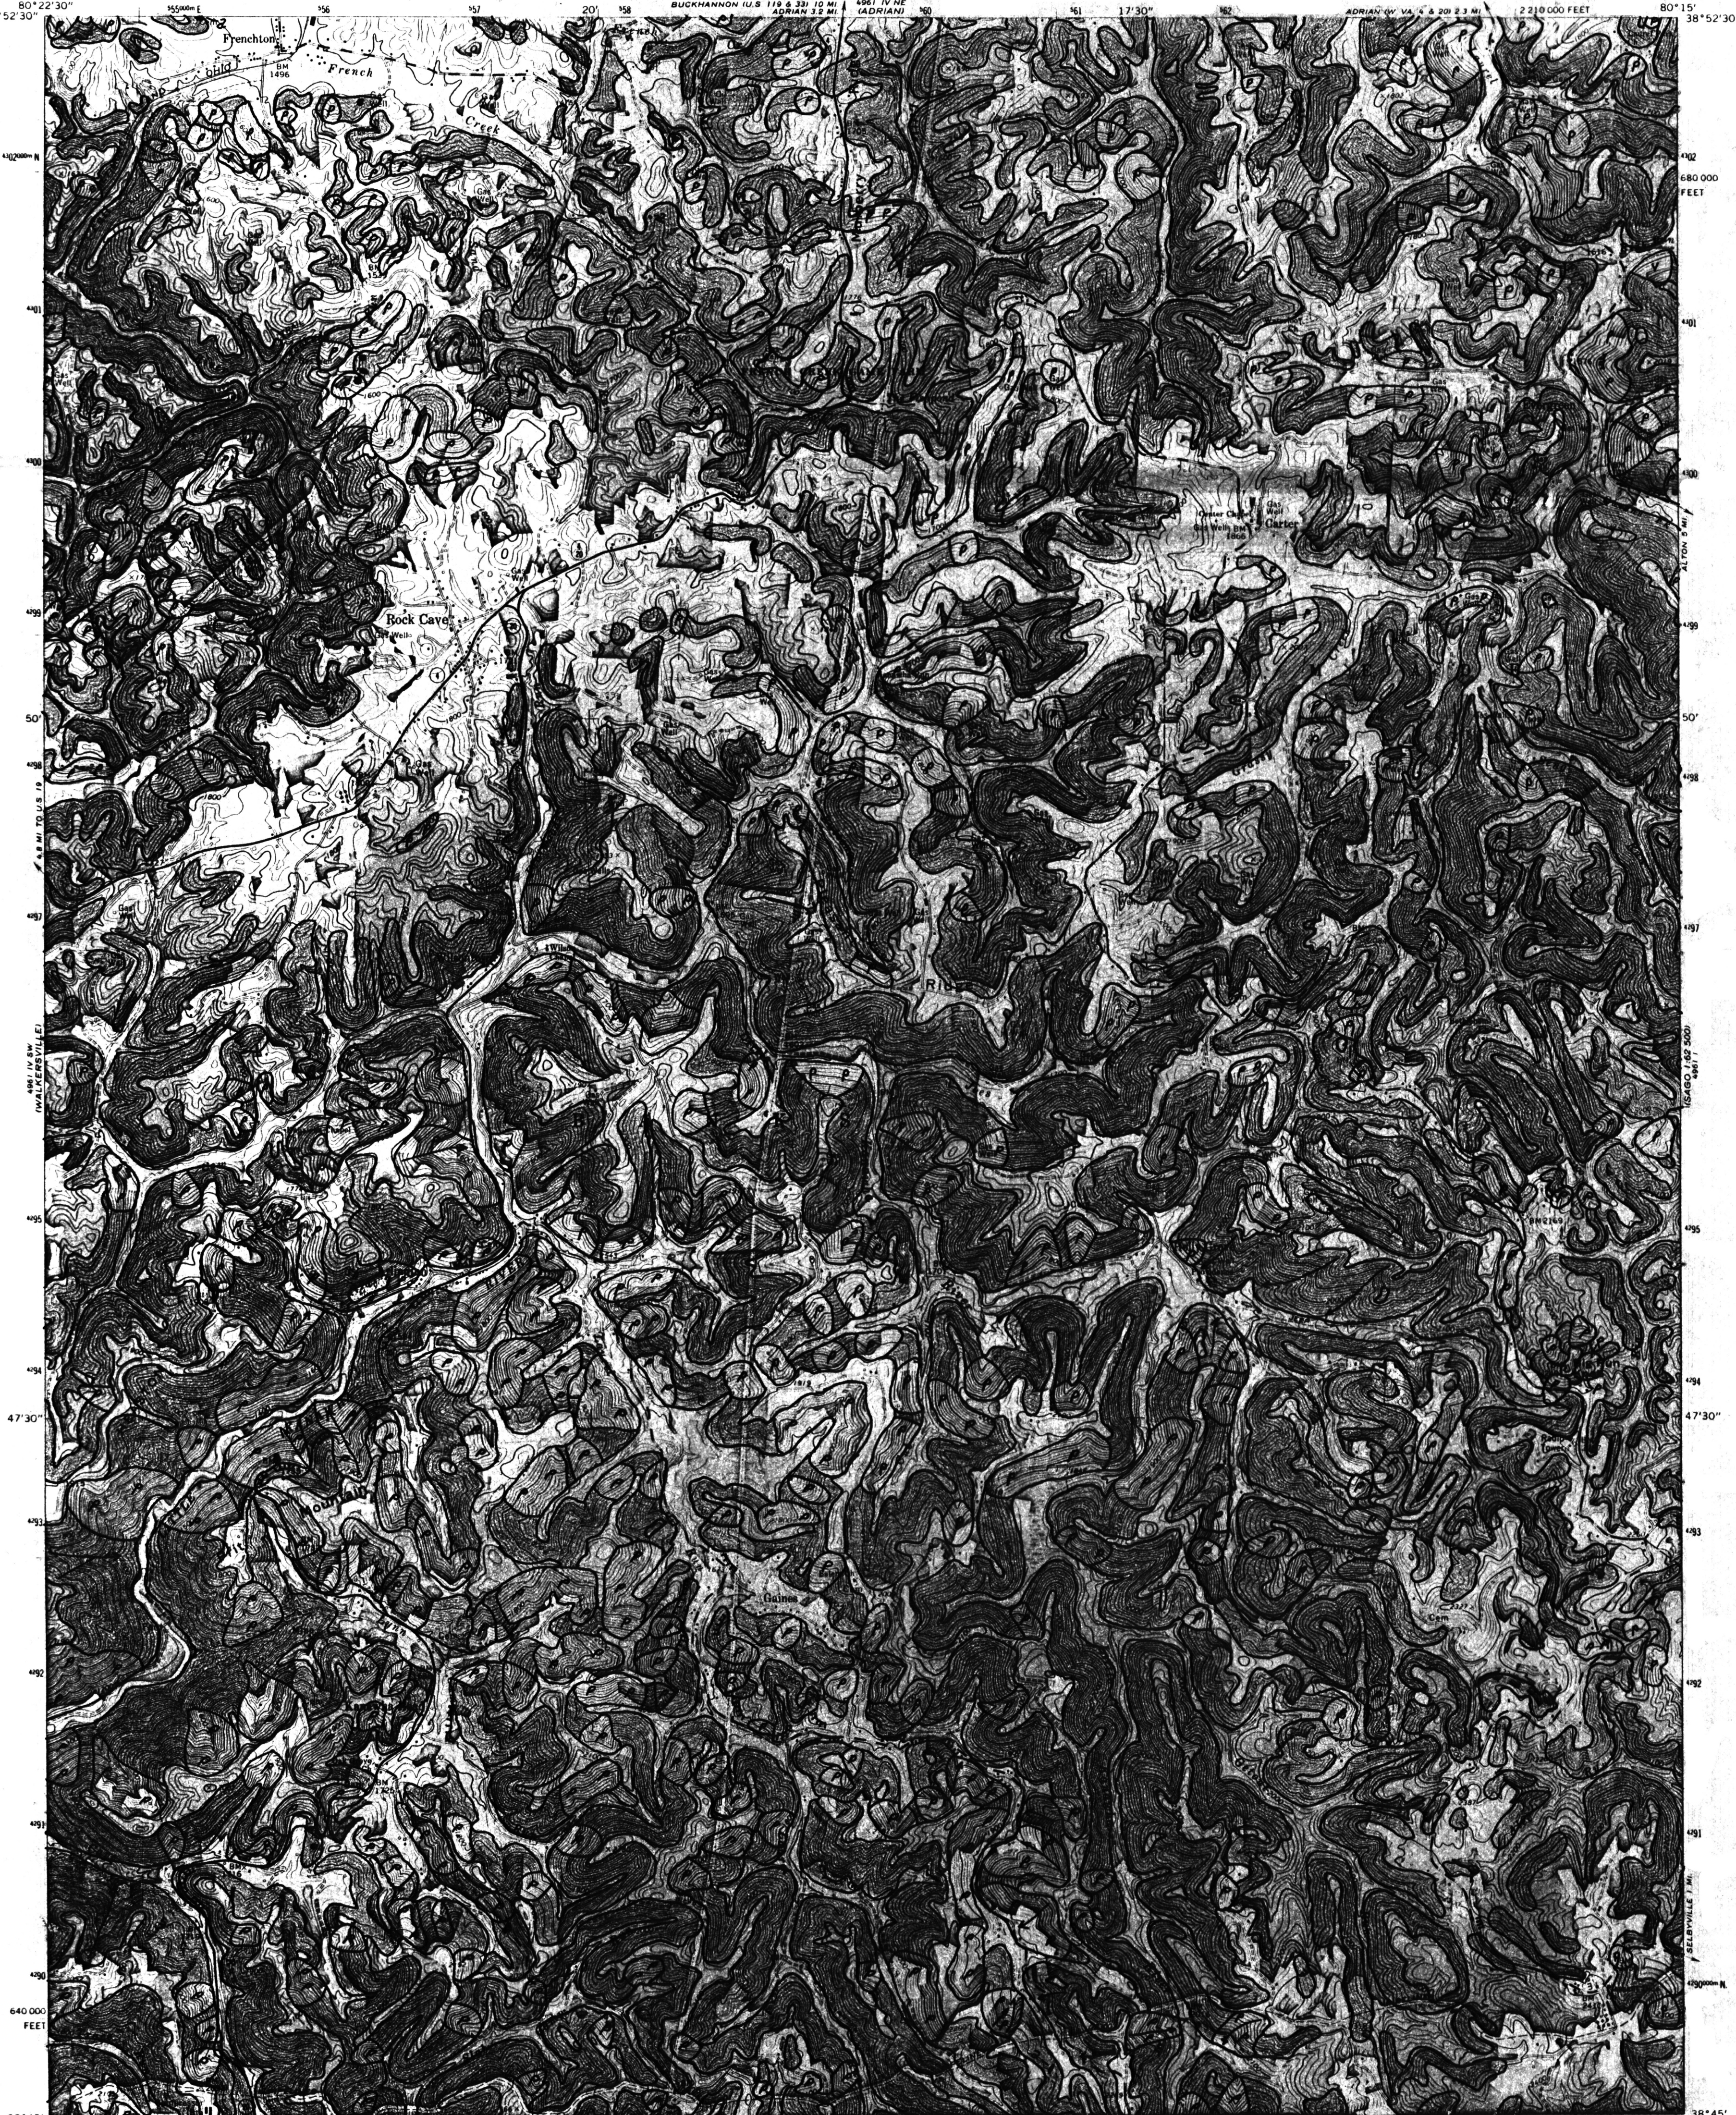
ACTIVE OR RECENTLY ACTIVE LANDSLIDE
Complex landslide composed of earthflow, debris
slide, earth and rock slump. Identified from
historical records, and from scars, debris and
other field evidence. Ground extremely unstable;
sliding accelerated by excavation, loading and
changes in drainage conditions. May include
areas with several active slides too small to
be shown separately.

OLD LANDSLIDE
Area of extensive hummocky ground caused by
earthflow and earth and rock slump. Lacks
clear evidence of active sliding. Relatively
stable in natural, undisturbed state,
generally not affected by small structures properly
sited in areas away from the edge of the toe,
can be reactivated by extensive, rapid exca-
vation, loading, and changes in ground water and
surface water conditions. Area of old landslide
probably includes recent ones not identified
from field evidence or otherwise documented.
Upslope boundary of landslide generally defined
by modified scarp, but downslope (toe) may be
gradational and not well defined.

COLLUVIAL SLOPE
Valley wall along major streams with slope as
steep as 40° (85%), stony, clayey silt soil up
to 50 ft. (15 m) thick; commonly buttressed by
a terrace or bench at the toe of the slope, very
susceptible to sliding by cutting of toe area,
removal of terrace or bench, and overloading,
slide commonly activated without apparent cause.

**AREAS SUSCEPTIBLE TO DEBRIS FLOWS AND DEBRIS
AVALANCHES**
Primarily shallow, narrow ravines and chutes with
accumulation of stony colluvium generally 10 ft.
(3 m) or less in thickness; susceptible to rapid
movement during intense rainfall. Most ravines
and chutes designated show evidence of former
debris flows and avalanches. Symbol-a desig-
nates historical debris flow or debris avalanche.

AREAS SUSCEPTIBLE TO ROCKFALL
Steep, locally vertical, natural and man-made
slopes and cliffs, 15 ft. (4.5 m) or more high,
formed dominantly of sandstone, limestone, sandy
shale, mudstone and claystone. Interbedded mud-
stone, claystone and shale weather rapidly leaving
sandstone and limestone rock faces unsupported.

SOIL AND ROCK SUSCEPTIBLE TO LANDSLIDING
Soil and rock similar to that involved in land-
slides elsewhere in map area; primarily areas
underlain by claystone, mudstone and shale
associated with other rock types. Rock weathers
rapidly on exposure forming clayey soil highly
susceptible to sliding. Includes coves (U-shaped,
shallow valleys) containing thick layers of clayey
soil that are very susceptible to sliding where
excavation breaks continuity of slope and where
overloaded by artificial fill.

AREAS LEAST PRONE TO LANDSLIDES
Map areas in which no patterns or symbols are shown;
primarily valley floors, ridge tops and broad
benches; modification by excavation and fill may
lead to local landslides.
